NEVATOWERS

“NEVA TOWERS” is a multifunctional complex consisting apartments, offices and retail areas currently under construction at the plots № 17-18 of the International Business Center “Moscow City” located in the Krasnopresnenskaya Embankment

Detailed Stack Effect Study – Draft Report

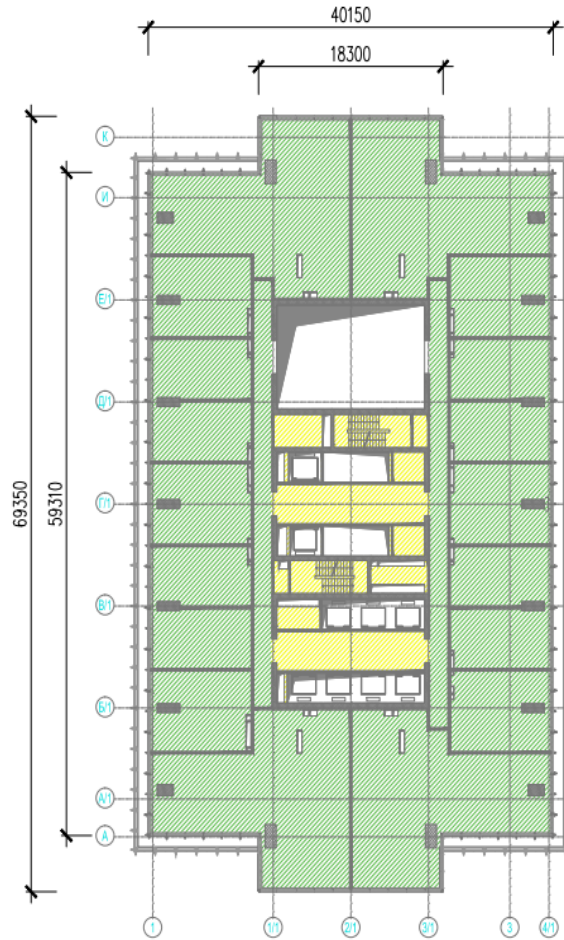
T1- Apartment Midrise Typical Floor Plan

- APARTMENT 1980,94 m²
- CORE 575,92 m² (thickness 500mm)

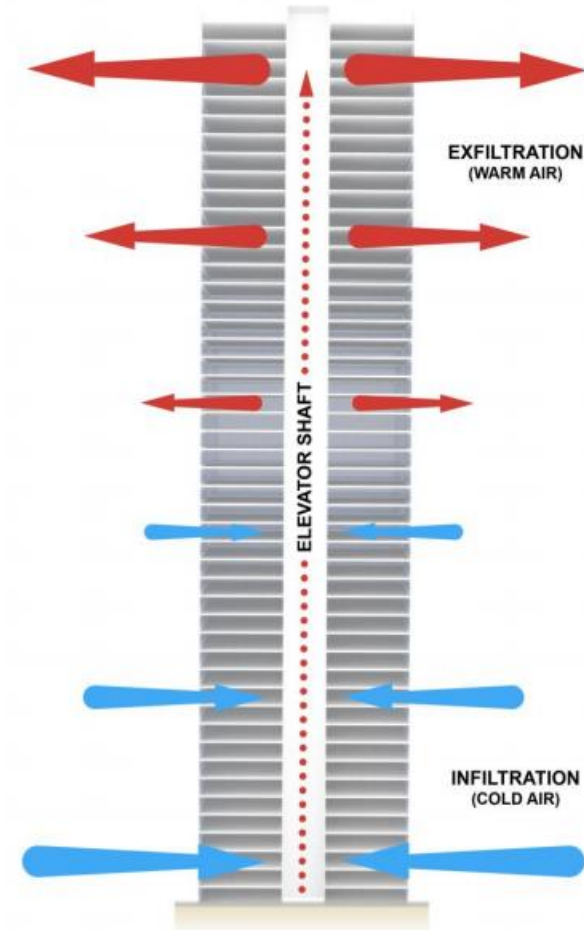
Figure 1: Conceptual image of normal (winter) stack effect airflows in a building.

Stack effect is a phenomenon that can exist in all buildings and is induced by the buoyancy force originated from indoor-outdoor temperature differences. A conceptual image illustrating typical impacts of stack effect during heating seasons, which is commonly referred to as *normal* stack effect, is shown in Figure 1. During cooling seasons, *reverse* stack effect occurs and the directions of airflows are the reverse of that shown in Figure 1.

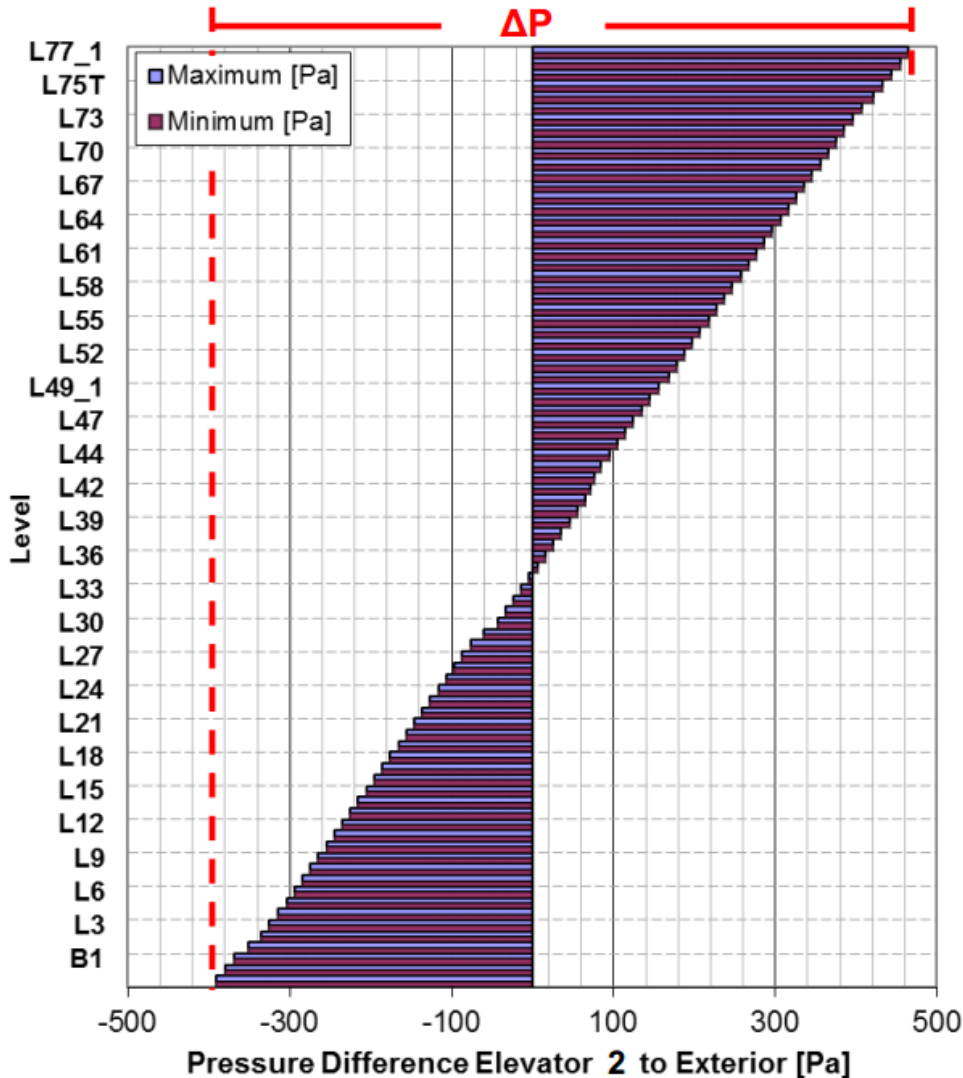
- Figure 13 shows the pressure difference between the Elevator 2 shaft and exterior space on a very cold day in Moscow.
- In this case, ΔP is approximately 850 Pa on a very cold day. In comparison with T1 Case 1 (Figure 3), the pressure difference in T2 is higher due to the larger height of the tower and the higher temperature difference between the interior and the exterior in comparison to T1.
- The peak positive pressure difference is 460 Pa on L77_1, and the peak negative pressure difference is -390 Pa on B3.

Figure 13: Pressure difference between Elevator 2 and the exterior during winter, calm wind – T2 Case 1

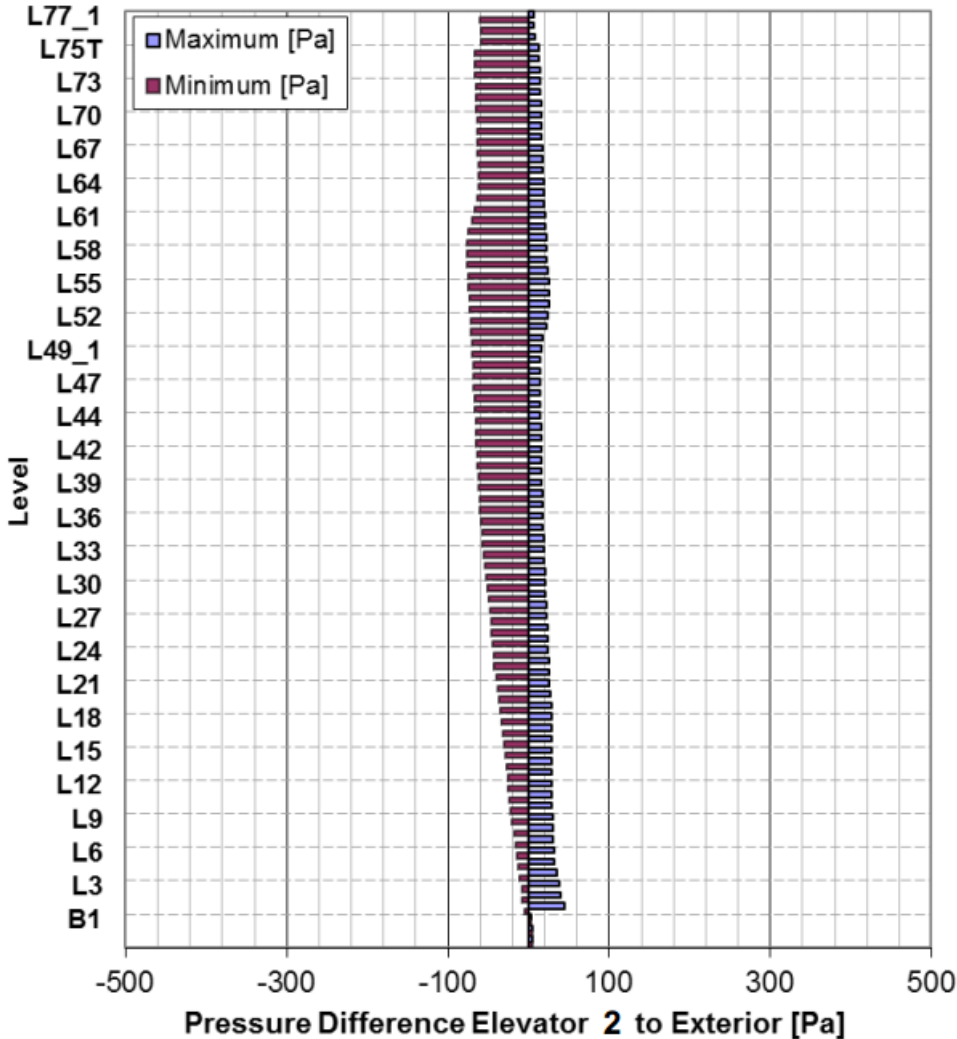
- Figure 16 shows the pressure difference between the Elevator 2 shaft and the exterior space on a very hot and windy day in Moscow.
- Similar to T1 Case 4, many levels have both positive and negative pressure differences between the shaft and the exterior space as result of the low stack effect pressure difference and a combination of positive and negative wind pressures on different sides of the building.
- The peak shaft-to-exterior pressure difference occurs on L59 and is approximately -80 Pa.
- Since the pressure differences between the shaft and the exterior space are below 130 Pa, swing door operability issues are not likely to occur on hot windy days.

Figure 16: Pressure difference between Elevator 2 and the exterior during summer, 25 km/hr Southwest wind – T2 Case 4
